# An Analysis of Tensile Failure Process of 3D Carbon-Carbon Composites

Jiang Dong-Hua  
Li Min-Jing  
Wang Cheng-Fang  
Beijing Research Institute of Material  
and Technology  
China

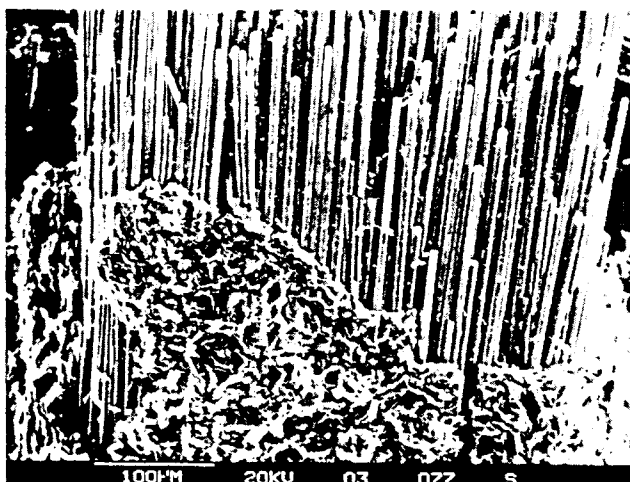
Figure 5.

Fig.5. shows a piece of matrix bonded on a fiber bundle. There was a rather extensive crack network on it. Other piece of matrix which was debonded removed from the bundle. While the fibers within bundle aligned straightly without damage.

It could be recognized that under the tensile loads, the cracks of specimen started from the matrix regions. When the matrix crack propagates to the fiber surface, stop there, then the crack immediately turn 90° and propagates along the fiber-matrix interface. In the cases of Fig.5. and Fig.6. it causes a partial debonding between the fiber and the matrix. It could be considered tensile strength primarily depends on the strength of the fiber bundle in that direction. Compared with fiber bundle, matrix region and interface between fiber and matrix exhibit relatively low tensile strength. Also there are a large number of crack networks in the matrix region and interface. Hence, as increasing tensile load acted upon the unit cell in a fiber bundle direction, interface will separate. At load levels near those required to cause fiber bundle

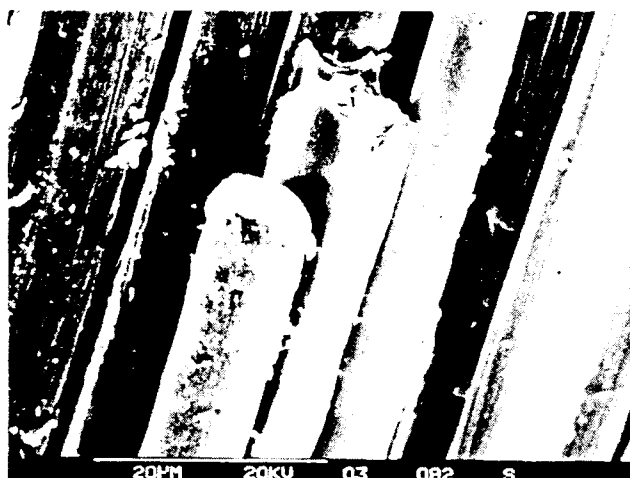
Figure 6.

Fig.6. shows a pattern of some fibers in the fiber bundle, from it the matrix was broken and separated.
